DEPARTMENT OF NATURAL RESOURCES

Minerals	Inspection	Report

Rep	oort Date: 11/13/201	13		
Mine Name: Maynard Topaz		Permit Number:	S/023/0099	Mine Status:	Inactive
Oper	ator Name: : Colorado Calumet Co. Inc	Inspection Date:	08/22/2013	Permit Fees:	Paid
Inspector(s): Paul Baker and Wayne Western Inspection			9:15-9:30 AM	Bond Amount:	\$4,000
Atter	ndee(s):	Weather:	50s, mostly cloud	dy Bond Escalation:	08/04/2013
Inspection Purpose: Operator requested bond release				Prior Inspection:	08/26/2013
Conc	clusions and Recommendations getation is adequate, and the remaining surety show	ıld be released.			
Elements of Inspection			E	valuated & Commented	Enforcement

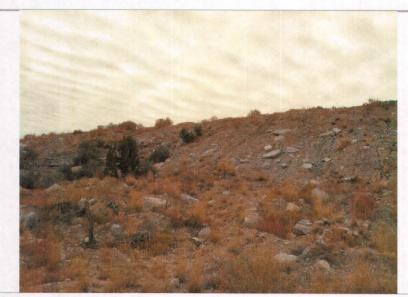
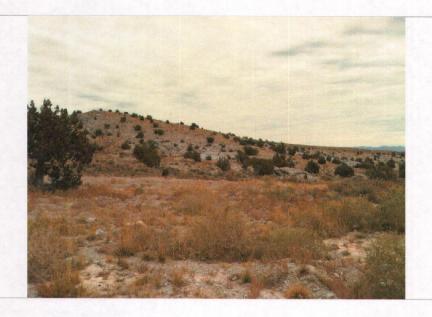
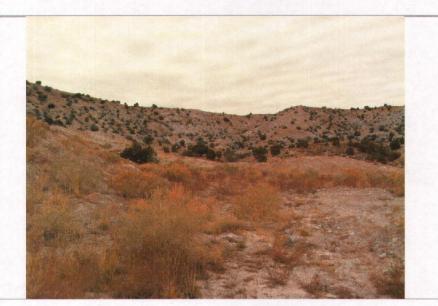
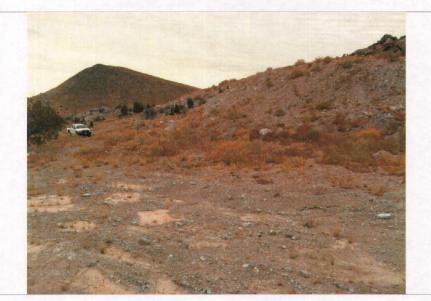
8.	Soils				
9.	Revegetation			\boxtimes	
	After driving miles over halogeton, Russian thist the vegetation is fourwing saltbush, forage kochia probably either bluebuch wheatgrass or slender w sagebrush, probably Wyoming big sage. I did not disturbed area was clearly at least 70 percent of the disturbed area have less vegetation than others, but are plants growing even in those areas that appear	i, Indian ricegrass, and a per heatgrass. The vegetation of think it was necessary to take the cover in undisturbed area at I was impressed with two	rennial bunchgrass community in surro ake vegetation covers. As can be seen	which I did not try to id bunding areas was domin er measurements because in the photos, some parts	entify. It is nated by e cover in the s of the

The photos are all overviews of the reclaimed area.
